Manhole Inspection Summary

Manhole # S29GG1003MH

Insp Date: **12/29/06 10:21 AM**

Location Address: **622 40TH ST**

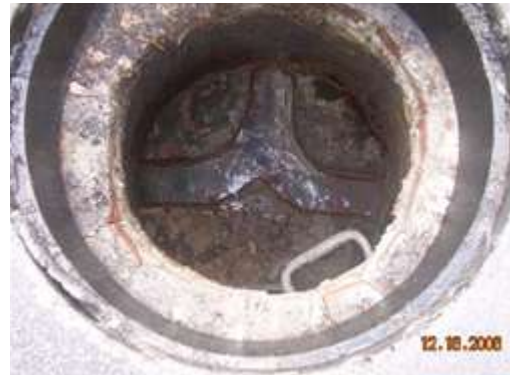
Top View

Bench and Channel debris.

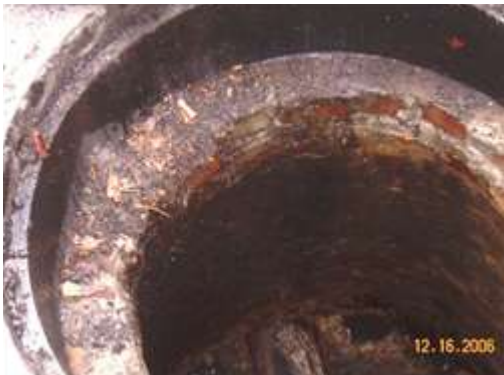
Defect

Offset: **4** (in.)

☒ **Leaks**

Infiltration: ☐ None ☒ **Joint** ☐ Cracks ☐ Mortar ☐ Roots ☒ **Wall**

Frame leaks. Frame offset. Adjustment infiltration.

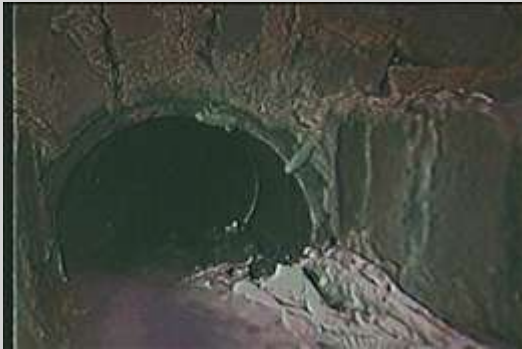
8 in. Circular Gravity Sewer Pipe Out @ 12 O'Clock

Deposits: ☐ None ☐ **Mud** ☐ Sludge ☒ **Debris** ☐ Grease

Infiltration: **Evidence** Pipe Seal Cond: **Cracked**

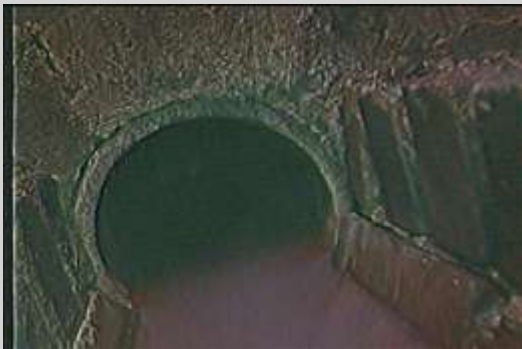
8 in. Circular Gravity Sewer Pipe In @ 3 O'Clock

Channel deterioration.

Infiltration: **Evidence** Pipe Seal Cond: **Unknown**

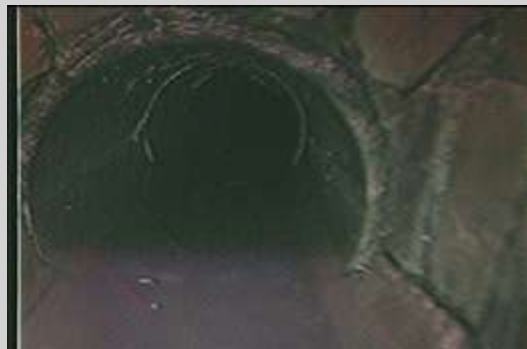
Pipe In @ 9 O'Clock

Deposits: ☐ None ☒ **Mud** ☐ Sludge ☒ **Debris** ☐ Grease

Infiltration: **Evidence**

Pipe Seal Cond: **Cracked**
